6 Speed Transmission mechatronic sleeve replacement

FAILSAFE, NO COMMUNICATION WITH TRANSMISSION POSSIBLE

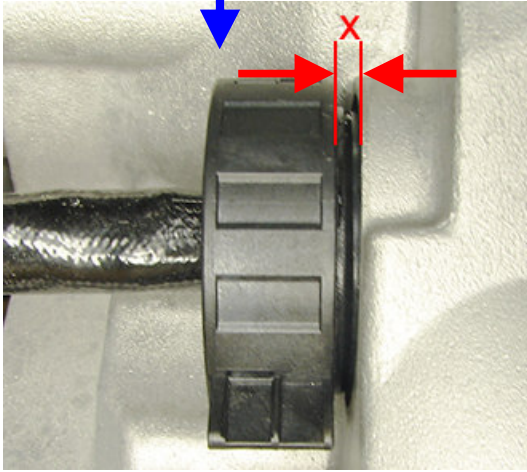
ANY MECHATRONIK SLEEVE REPAIRS ? CHECK GAP X BETWEEN HOUSING AND CONNECTOR.

IS THE GAP X LARGER THAN 3.0mm ?

WITH PROPERLY SEATED SLEEVE THE GAP IS APP. 3.0mm. IF LARGER THEN THE SLEEVE IS NOT PROPERLY SEATED IN THE MECHATRONIK. REINSTALL SLEEVE PROPERLY

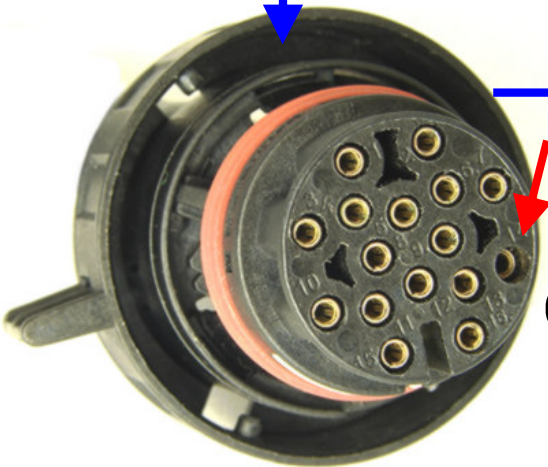
CHECK FOR PUSHED BACK PINS AT THE VEHICLE ELECTRICAL CONNECTOR TO THE TRANSMISSION

PINS PUSHED BACK ?

REPAIR AS NECESSARY

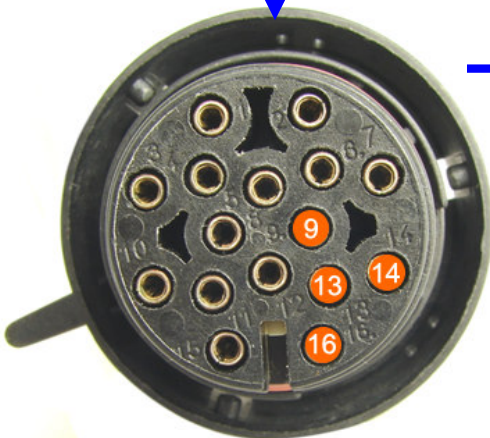
WITH VEHICLE CONNECTOR DISCONNECTED AND IGNITION ON CHECK VOLTAGE ON THE FOLLOWING PINS.

PIN 13 TO PIN 14 – RECORD VOLTAGE
PIN 13 TO PIN 9 – RECORD VOLTAGE
PIN 16 TO PIN 14 – RECORD VOLTAGE
PIN 16 TO PIN 9 – RECORD VOLTAGE

IS VOLTAGE BETWEEN ALL PINS BATTERY VOLTAGE ?

RECOMMEND MECHATRONIK REPLACEMENT

TROUBLESHOOT POWER PATH - FUSES
